D. Weld Repair of the U.S. Capitol Dome

by T.A. Siewert and C.N. McCowan, Nat. Inst. for Standards and Technology, Kevin Hildebrand and C.A. Stillions, Office of Architect of the Capitol, R.A. Bushey, J. Doherty, and T. Christ, ESAB Welding and Cutting Products, D.J. Kotecki, Lincoln Electric Company, D.L. Olson, Colorado School of Mines, L.W. Myers, Jr., Consultant (formerly with Dresser Rand Co.), and E. Hinshaw and S. Kiser, Special Metals Inc.

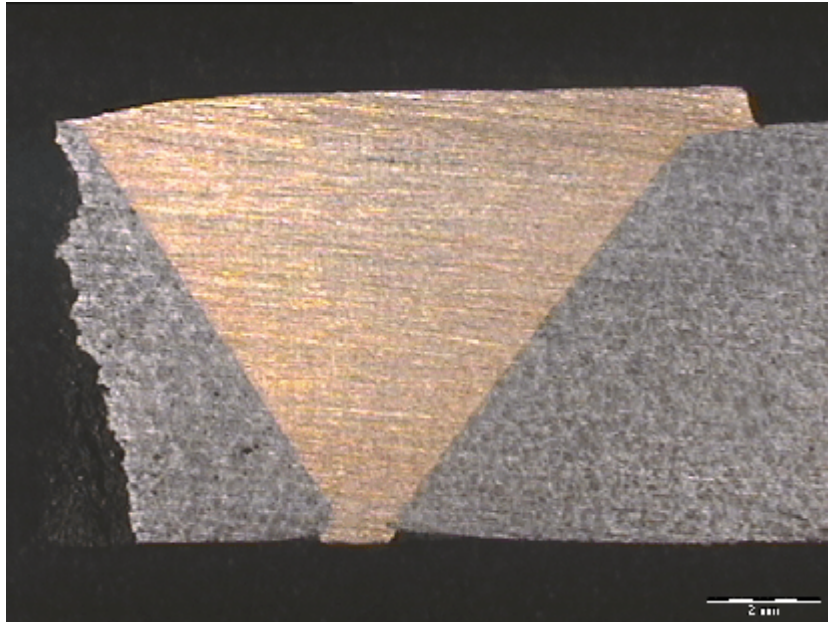
Figure 1 shows the cross section through the low-fuming bronze joint at a magnification of about 10 X. The bronze shows good fusion to the cast iron and no porosity is visible at this magnification. Figure 2 shows the cast iron-bronze interface at higher magnification (about 100 X). This image, taken before etching the surface, clearly reveals the carbon flakes in the cast iron (on the left), and a few pores in the bronze, especially along the interface. Since no fracture or cracks occurred at the pores, they have no effect on the integrity of the joint. The interface between the cast iron and bronze is straight (confirming the expected low solubility of the cast iron in the bronze), yet with good wetting (confirming the ability of the bronze to bond to the cast iron surface). A microhardness traverse was made across the braze weld in specimen WM-2. The hardnesses in the weld and HAZ were quite similar indicating the absence of martensite in the HAZ.

Figure 1. Cross section through specimen WM-2, showing the 75 deg. included angle.(10 X)

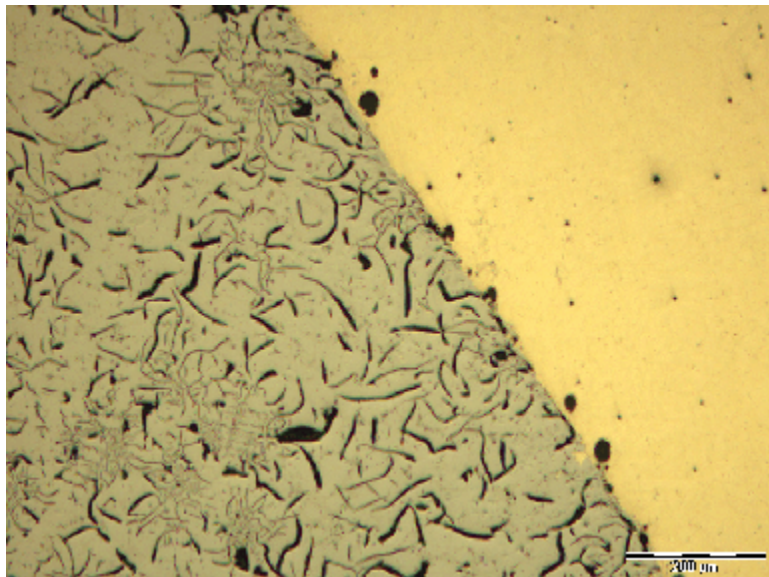
Figure 2. Higher magnification view of Figure 1, showing the interface between the cast iron (left) and the low-fuming bronze (right). Carbon flakes are visible in the cast iron. (~ 100 X)

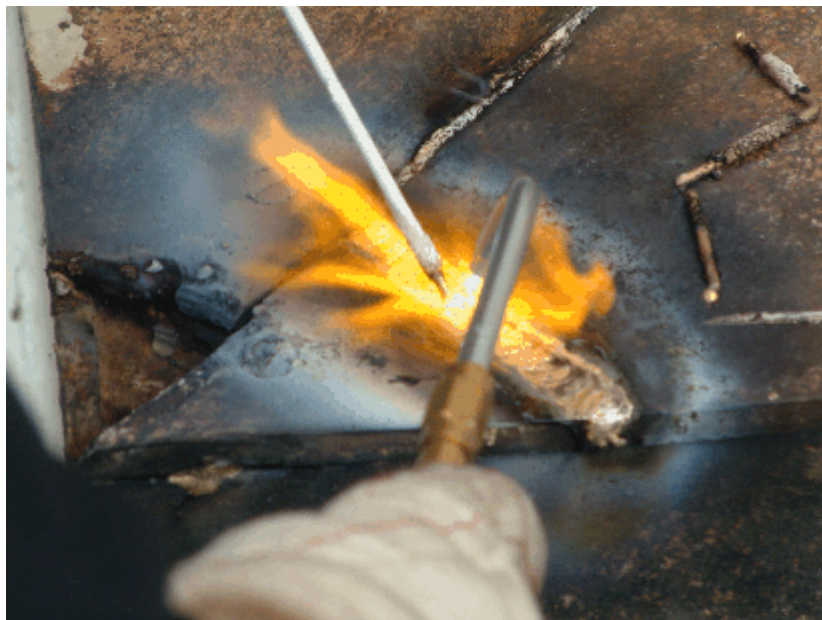
We repaired a total of four cracks, in two locations. Figure 3 shows the repair being performed at location 1, at a corner (just about 0.5 m above the roof of the main

part of the Capitol) where two castings met. The actual cracks were on the horizontal shelf between about 8 and 14 cm from the corner of the casting, one crack on each casting. One crack passed through a bolt hole (used to fasten the corner), and proceeded at about a 45 deg. angle from one edge to the other, a distance of about 8 cm. The other crack propagated above the bolt, also at about a 45 deg. angle and over a distance of about 12 cm.

We had planned, in the time that was available, to evaluate both oxyacetylene braze welding with low-fuming bronze and GTA buttering with nickel, however, we ran into a problem with the GTA technique when gases started to bubble from the pool. We think this may have been due to contamination (this area had been repaired before), and so just continued to use low-fuming bronze for the remaining repairs.

Figure 3. Location 1 - making the repair by braze welding.

Joint preparation: To get good fusion, the joint was opened up to give access to the bottom of the joint and to allow room to manipulate the puddle. The joints were ground to give a 2 mm (about 3/32 inch) root opening (minimum), and the sides were beveled to produce a 70 deg. (minimum) included angle.

The filler material was flux-coated low fuming bronze (60Cu-40Zn) meeting the requirements of American Welding Society (AWS) Standard A5.8, class RBCuZn-C. It is nominally 60 % Cu and 40 % Zn, but also contains about 1 % Sn, 1 % Fe, and smaller amounts of some trace elements. The diameters used for this repair work were 2.4 and 3.2 mm (3/32 and 1/8 inch).

Before braze welding, the cast iron was preheated by continually moving the torch over the cast iron (never keeping it in any place long enough to overheat the casting). The preheat temperatures were approximately 260 to 315 deg. C (500 to 600 deg. F) in an area 10 to 13 cm (4 to 5 in.) adjacent to the joint to be brazed. The actual temperature used for the braze welding is near 982 deg C (1800 deg F). A neutral flame was used throughout the repair operation.

Approximately 4 to 5 passes were used to fill the joints in the cast iron (nominal thickness of 8 mm). After completion, the joints were ground to match the height of the cast iron.

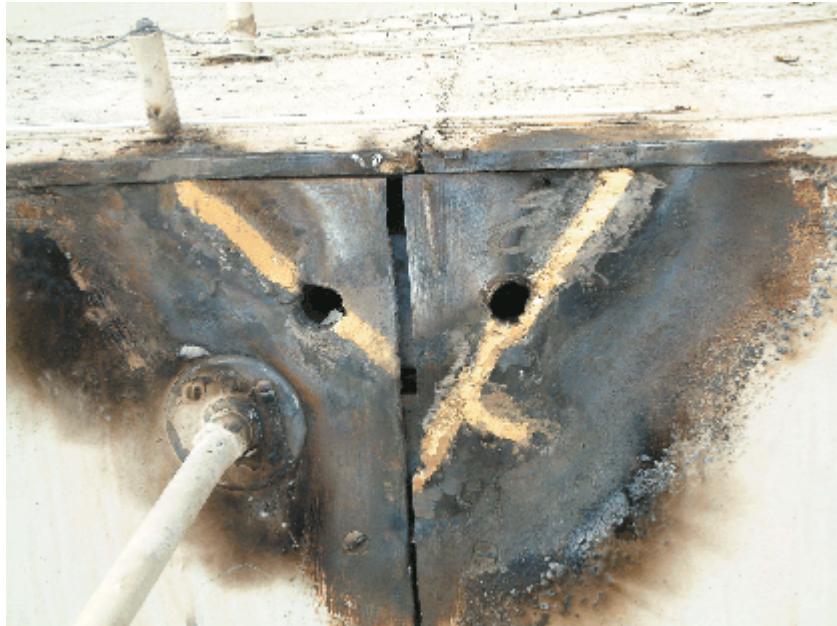
Figure 4 shows the final appearance at location 2, on a wall (about 2 m above the roof of the main part of the Capitol) where two castings met. These two castings were almost perfectly flat. The actual cracks were about 15 to 20 cm in from the abutting corners of the two castings, one crack on each casting. Each crack passed through a bolt hole (used to fasten the corner), and proceeded at about a 45 deg. angle from one edge to the other, a distance of about 15 to 20 cm. During final grinding, we found a small crack (about 6 cm long) propagating at right angles to the repair. We think that this was a preexisting crack that had been hidden by the paint until the grinding operation. This crack was prepared by light grinding and was also filled with bronze. This other crack was at a right angle to the main crack, and proceeded down at a 45 deg. angle into the plate.

Figure 4. Location 2 - after finish grinding, but before painting.

The final inspection showed that the repairs were sound, and checks since then have not revealed any delayed cracking. In all, we proved that we can repair corner cracks, but may need to go back again some time to demonstrate repairs on the more complex geometries.

One repair ended with a bend in the joint, where the far corner of the casting was about 1 cm out from flush. The braze weld was reheated and the corner was gently hammered back to where it should be. Such an adjustment would never have been possible with a high-strength filler. Each repair was completed in less than an hour, and might proceed faster once the grinding and fixturing procedures are optimized. The grinding operation was purely for aesthetic reasons; it smoothed the surface and removed any excess buildup.
